Inspection Report

123 South St
Anyplace NJ 08000

DANTE Home Inspections

Date: 1/9/2020	Time: 10:00am	Report ID: Sample-HG Report
Property: 123 South St Anyplace NJ 08000	Customer: John Public	Real Estate Professional: Tom Test Realty Co

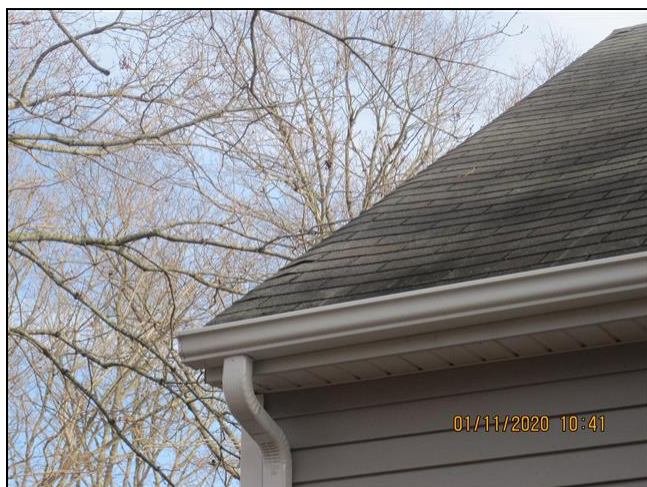
1.0 Item 1(Picture)

1.0 The roof covering is old, and the life of covering has expired. The covering does need to be replaced. While it could last a year or so, some areas may need patching with tar as leaks develop.

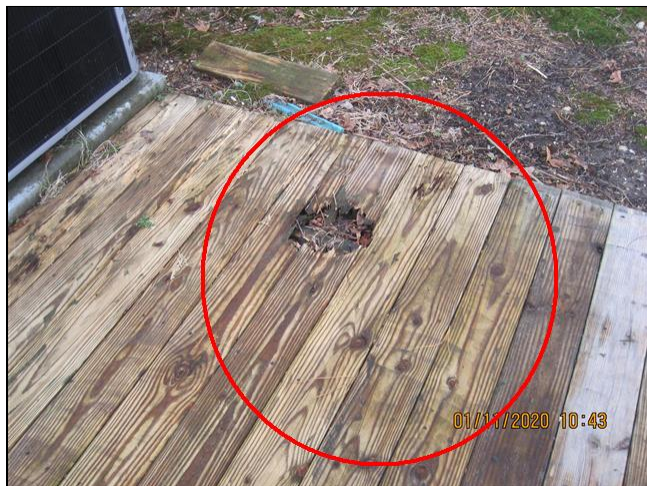
2.3 Item 1(Picture)

2.3 The deck is in poor condition and should be removed or replaced

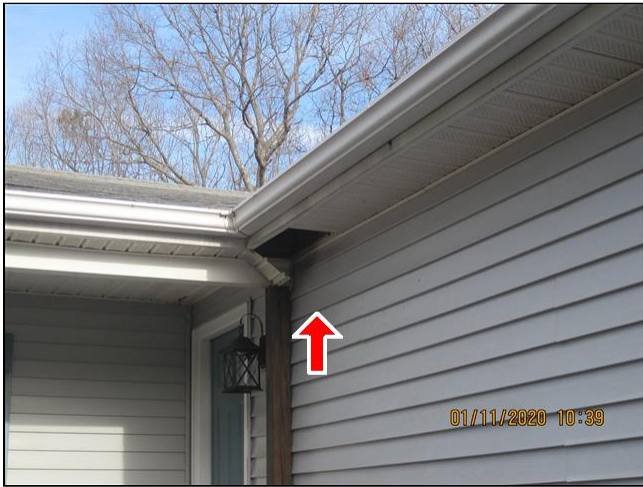
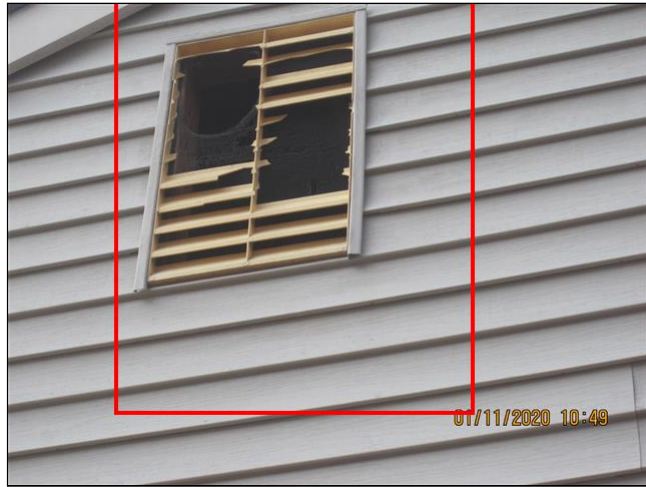
2.5 Item 1(Picture)

2.5 Soffit needs to be repair. Gable vent needs to be replace. Missing screen will be a entry point for animals and insects.

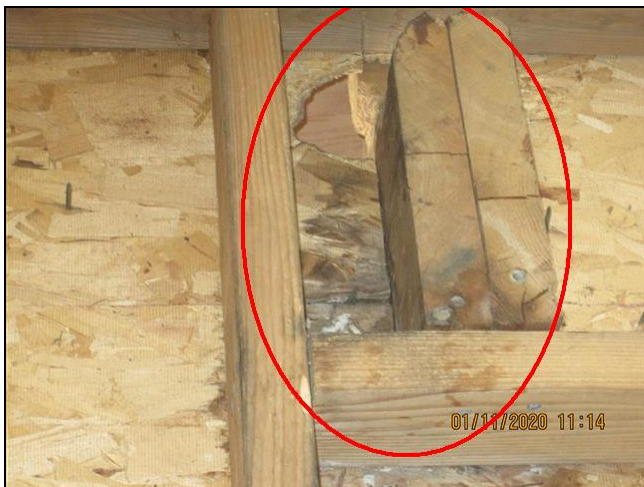
3.1 Item 1(Picture)

3.1 Shearing appears to have been chewed by an animal and is an entry point to the attic. Droppings in attic indicate that animals were in attic. Recommend contacting a professional to repair hole and contact a license exterminator.

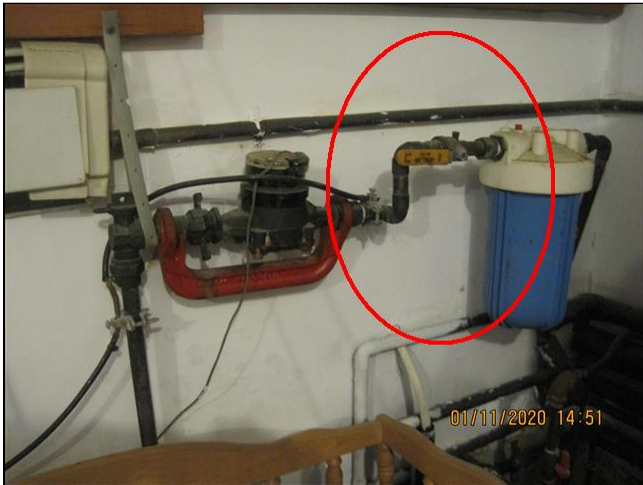
6.3 Item 1(Picture)

6.3 Main Water shut off in the basement

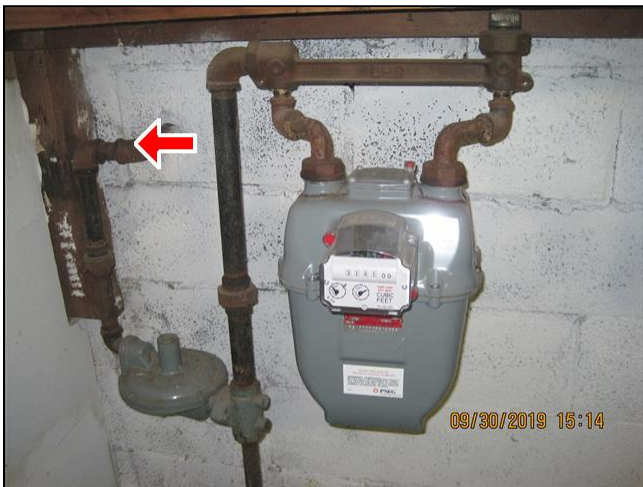
6.5 Item 1(Picture)

6.5 Main gas shut off in the basement

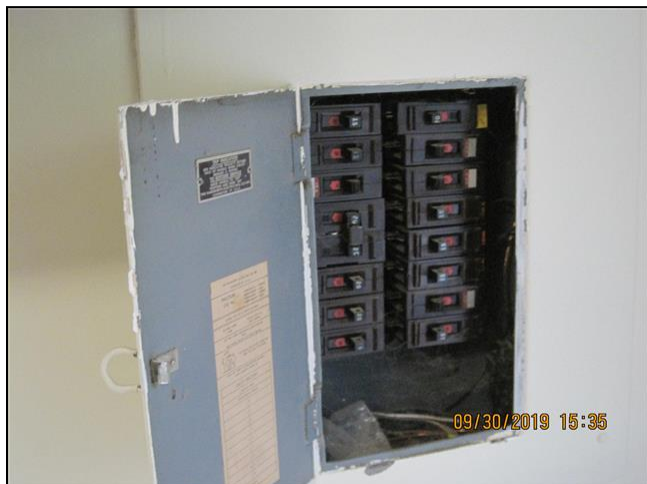
7.1 Item 1(Picture)

7.1 Main panel is missing a panel cover which is a safety hazard. Recommend placing panel cover and labeling circuit breakers.

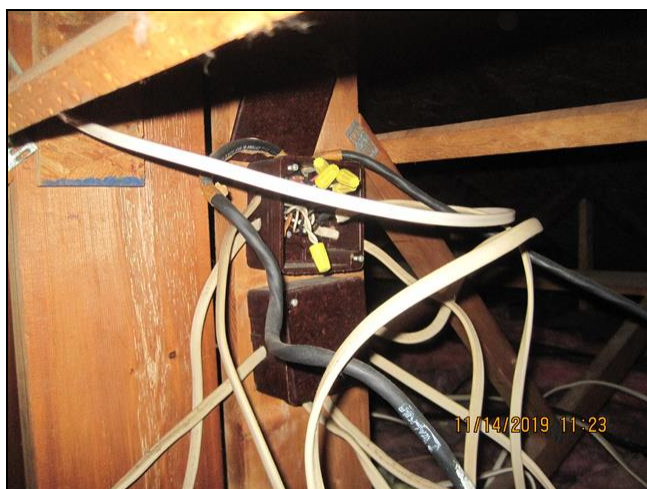
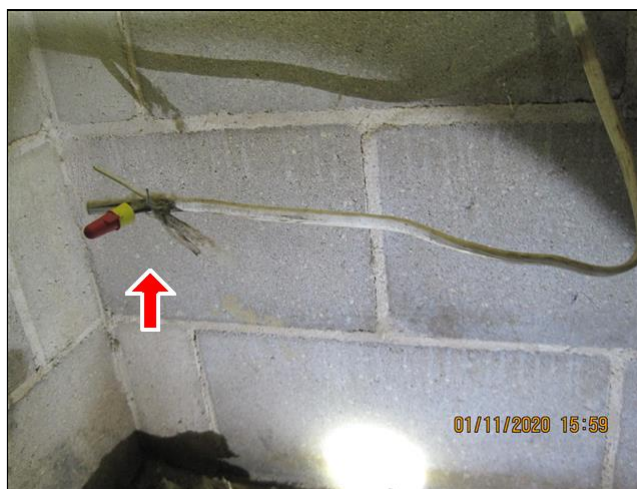
7.2 Item 1(Picture)

7.2 Open electric box in attic. Loose electric wire in basement.. Recommend calling a licensed professional to secure wires in attic and cover box. Terminate the loose electric wire in proper junction box.

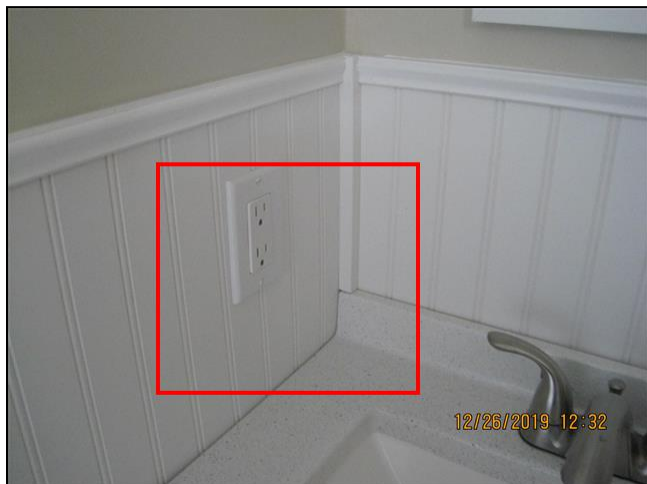
7.4 Item 1(Picture)

7.4 No GFCI present in main bathroom. Outlets within 6 feet of a water source needs to be GFCI protected. Recommend contacting a licensed professional to replace outlet with GFCI.

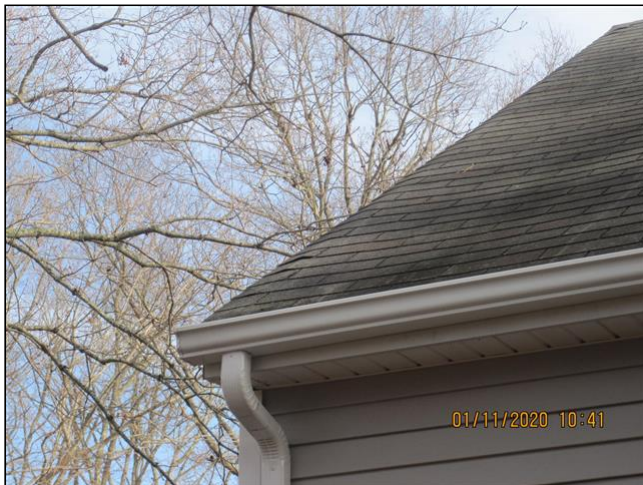
1.0 Item 1(Picture)

The roof covering is old, and the life of covering has expired. The covering does need to be replaced. While it could last a year or so, some areas may need patching with tar as leaks develop.

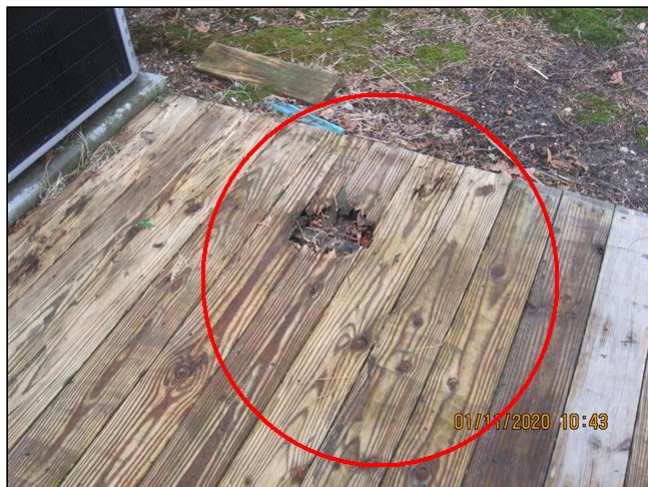
2.3 Item 1(Picture)

The deck is in poor condition and should be removed or replaced

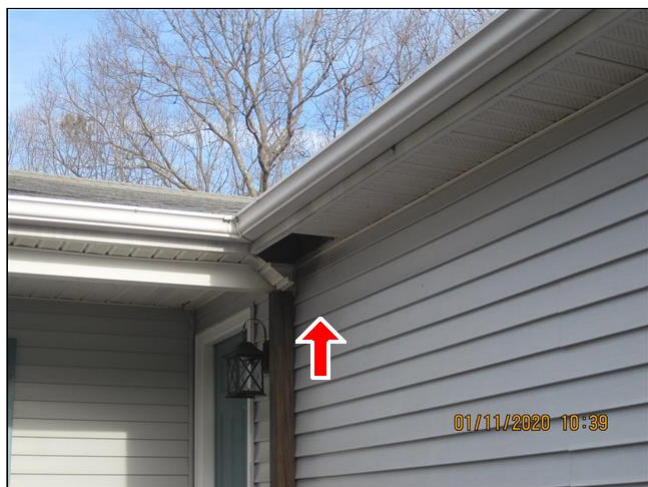
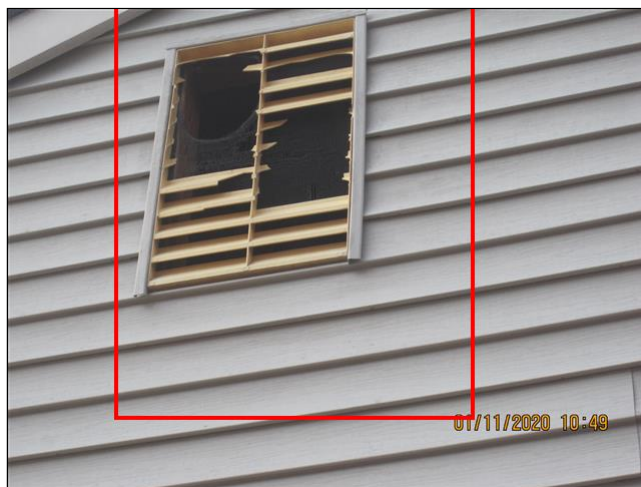
2.5 Item 1(Picture)

Soffit needs to be repair. Gable vent needs to be replace. Missing screen will be a entry point for animals and insects.

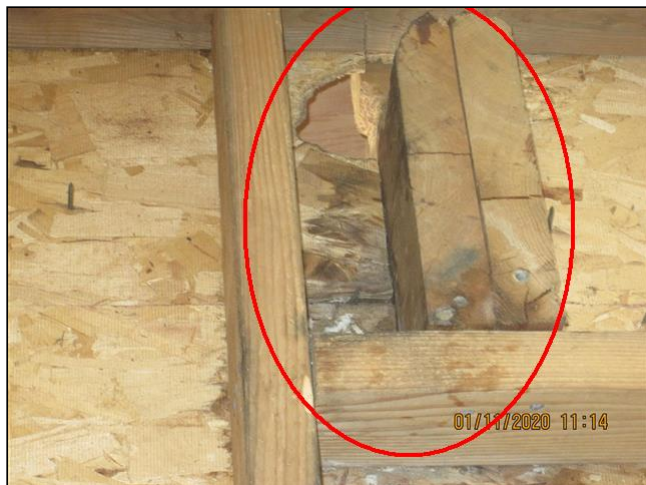
3.1 Item 1(Picture)

Shearing appears to have been chewed by an animal and is an entry point to the attic. Droppings in attic indicate that animals were in attic. Recommend contacting a professional to repair hole and contact a license exterminator.

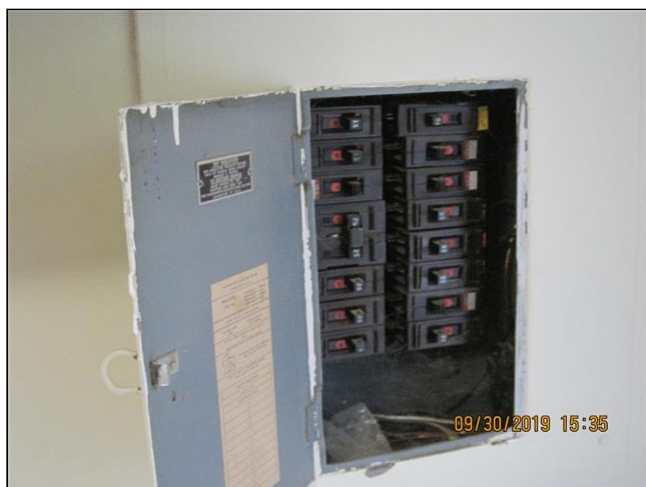
7.1 Item 1(Picture)

Main panel is missing a panel cover which is a safety hazard. Recommend placing panel cover and labeling circuit breakers.

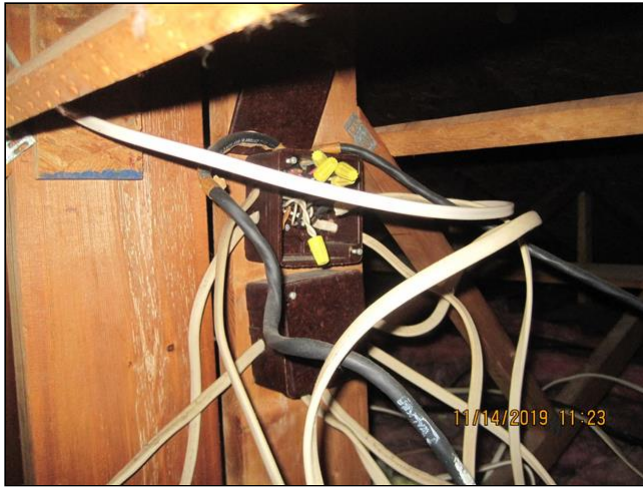
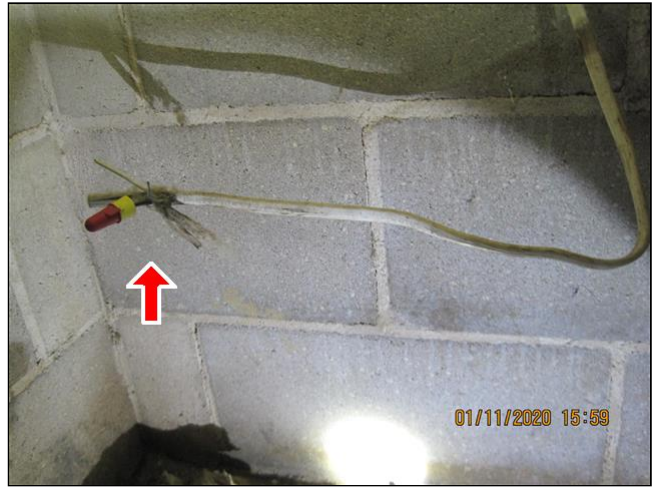
7.2 Item 1(Picture)

Open electric box in attic. Loose electric wire in basement.. Recommend calling a licensed professional to secure wires in attic and cover box. Terminate the loose electric wire in proper junction box.

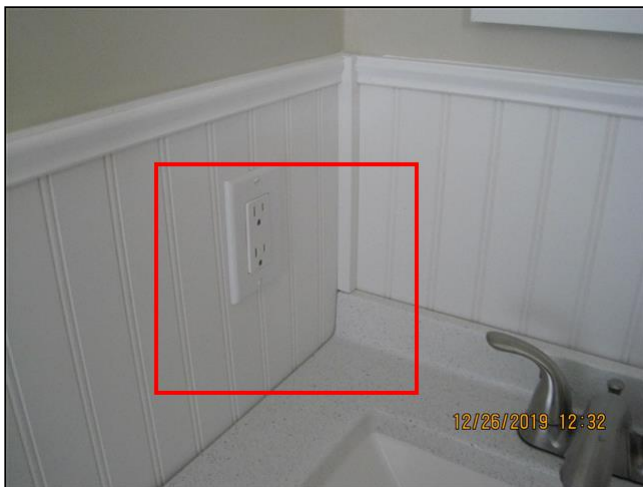
7.4 Item 1(Picture)

No GFCI present in main bathroom. Outlets within 6 feet of a water source needs to be GFCI protected. Recommend contacting a licensed professional to replace outlet with GFCI.
