Inspection Report

123 South St
Anyplace NJ 08000

DANTE Home Inspections

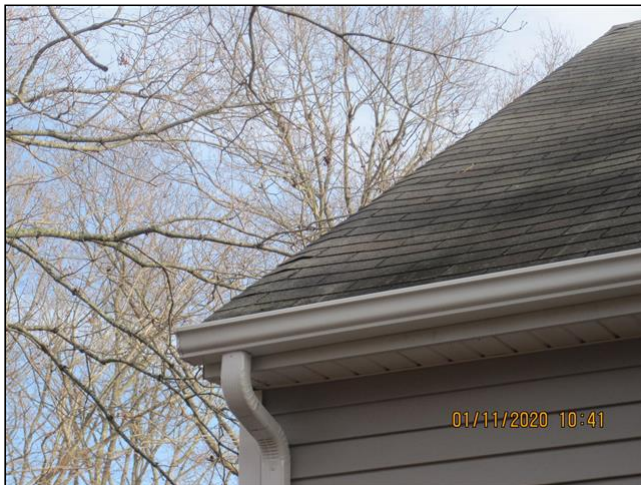
1.0 Item 1(Picture)

The roof covering is old, and the life of covering has expired. The covering does need to be replaced. While it could last a year or so, some areas may need patching with tar as leaks develop.

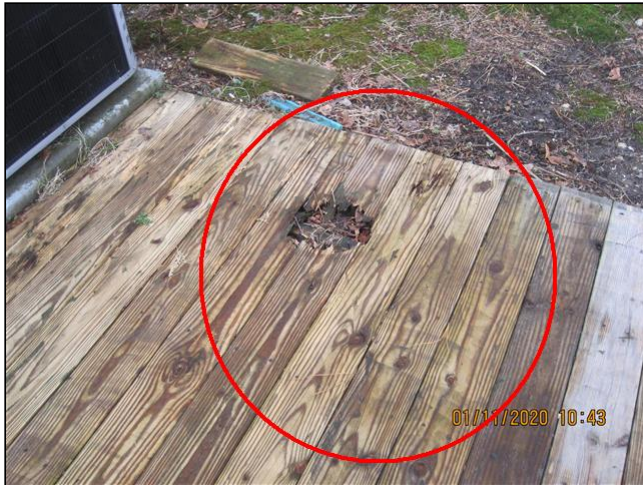
2.3 Item 1(Picture)

The deck is in poor condition and should be removed or replaced

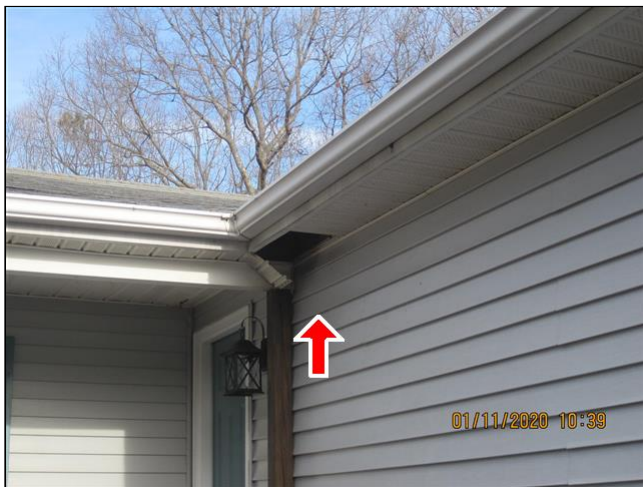
2.5 Item 1(Picture)

Soffit needs to be repair. Gable vent needs to be replace. Missing screen will be a entry point for animals and insects.

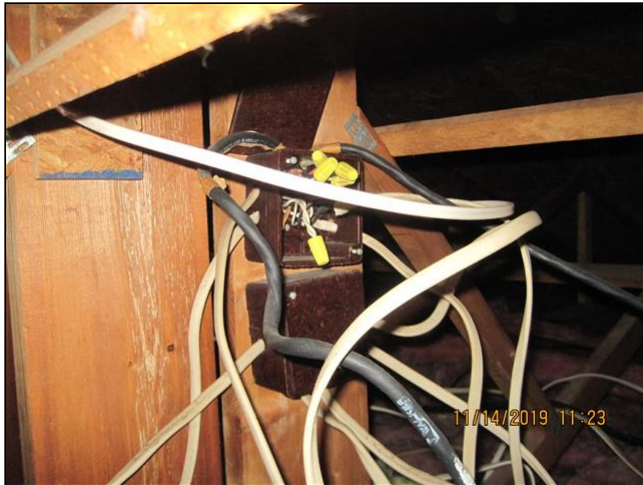
7.2 Item 1(Picture)

Open electric box in attic. Loose electric wire in basement.. Recommend calling a licensed professional to secure wires in attic and cover box. Terminate the loose electric wire in proper junction box.

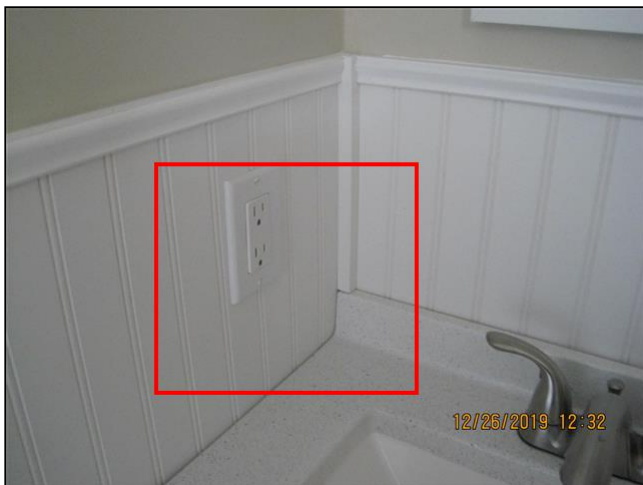
7.4 Item 1(Picture)

No GFCI present in main bathroom. Outlets within 6 feet of a water source needs to be GFCI protected. Recommend contacting a licensed professional to replace outlet with GFCI.
